# Road Safety Audit

Jefferson Street (US-52) & Joyce Road

Prepared By  
WSP in the US  
115 W. Washington Street, Suite 1270S  
Indianapolis, IN 46204

December 2025

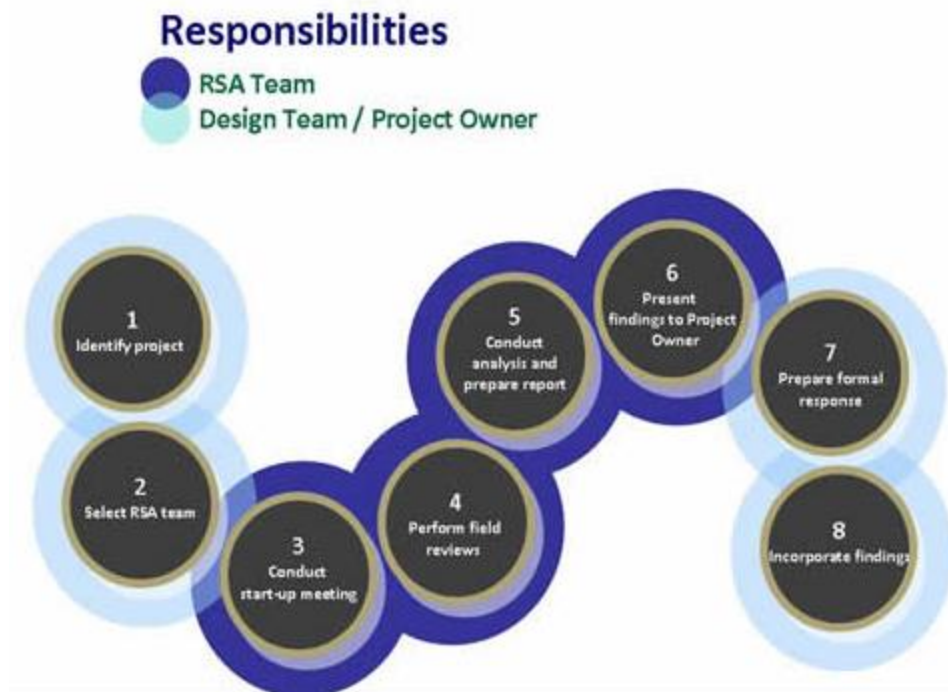
**Figure 1. RSA Eight-Step Process**

This Road Safety Audit (RSA) is being conducted on behalf of Will County, Illinois, with support and funding from the Chicago Metropolitan Agency for Planning (CMAP). The objective of this study was to conduct a formal safety performance examination of the Jefferson Street and Joyce Road intersection in Joliet, Illinois. RSAs are a proactive approach to addressing the safety of all road users, and involve identifying both safety issues and developing potential mitigation measures. The RSA followed the Federal Highway Administration's (FHWA) eight-step process, which is detailed in **Figure 1** below.

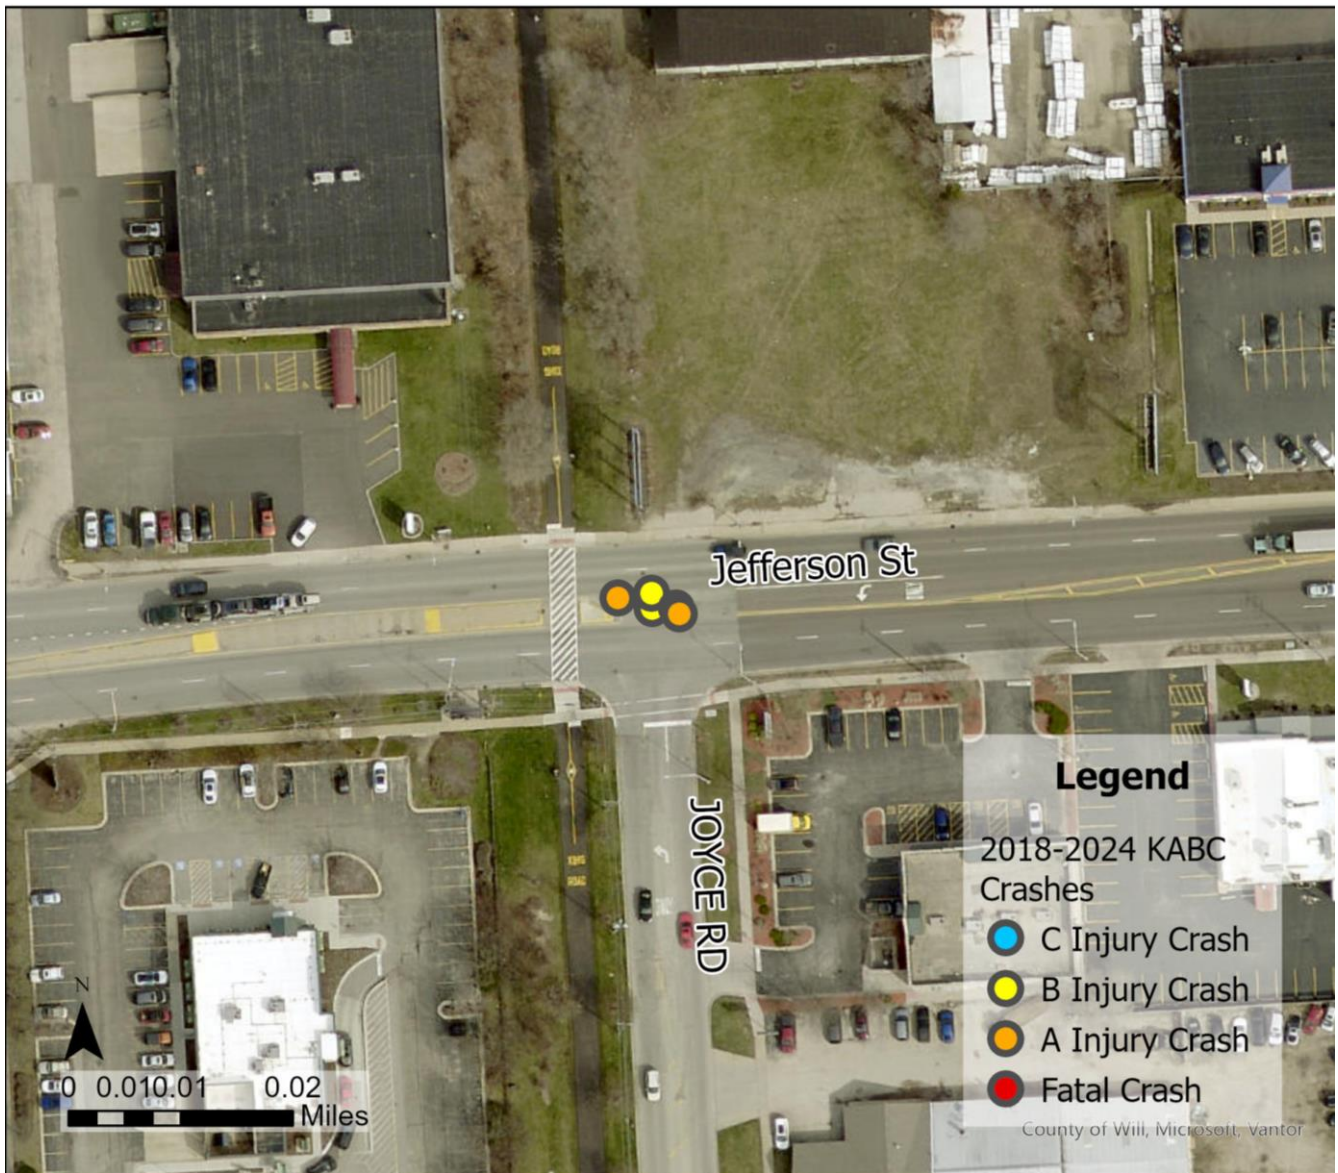
Figure 2. Crash Location Map

Crash data was provided by the Illinois DOT to identify crash patterns and trends that have occurred at the intersection. The time frame for crash data ranged from January 1, 2018, through December 31, 2024. The data provided detailed location, vehicle, and roadway characteristics of each crash. The crashes were summarized by crash severity, type, contributing factor, and environment. Figure 2 illustrates the location of the injury crashes that occurred in that timeframe at the intersection.

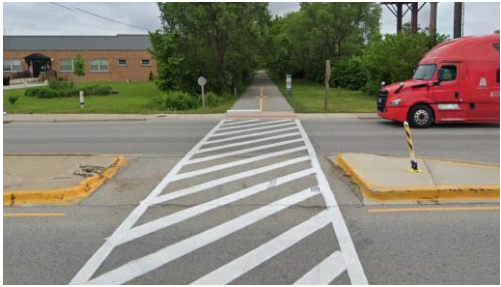
| Safety Measure | | Image |
|---|---|---|
| <b>Marked Trail Crosswalk</b> | A marked trail crosswalk is present on the west leg of the intersection. This allows the crossing to be more visible to the drivers. | |

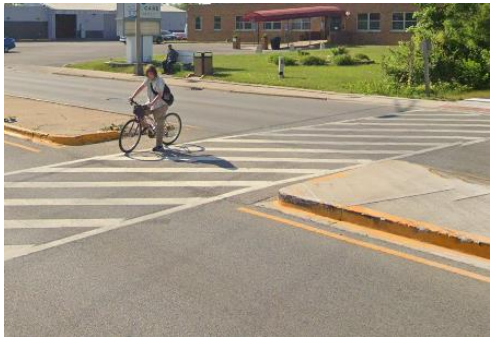
| Safety Measure | | Image |
|---|---|---|
| <b>Pedestrian Refuge Island</b> | A pedestrian refuge island is provided to allow trail users to cross Jefferson Street in two stages. | |

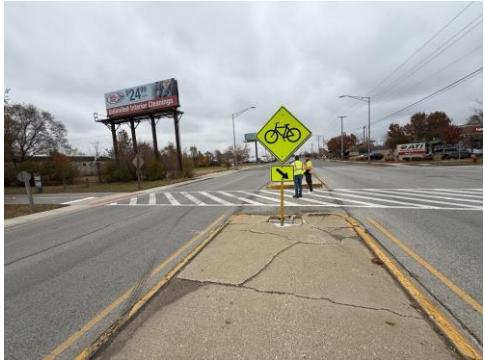
| Safety Measure | Image |
|---|---|
| <p><b>Bicycle Crossing Warning Sign (W11-1)</b></p> | <p>Bicycle Crossing warning signs are present EB and WB on Jefferson Street as you approach the trail crossing to alert drivers of the trail crossing.</p> |

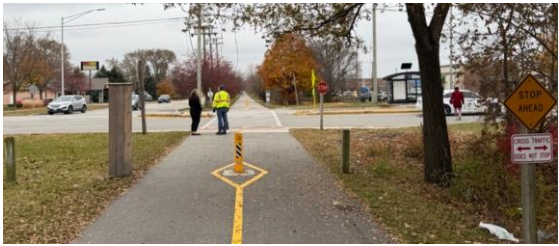
| Safety Measure | Image |
|---|---|
| <p><b>Trail Crossing Signs</b></p> | <p>Signs to warn trail users of the crossing and to stop users at the crossing are present in both directions.</p> |

| Safety Concern | Notes | Safety Treatment(s) |
|---|---|---|
| <b>Trail crossing</b> | <p>Lack of enhanced traffic control creates an uncomfortable environment for trail users, as vehicles aren't forced to yield to them.</p> <p>Crossing warning signs on the trail aren't distinctive or noticeable</p> | <ul style="list-style-type: none"> <li>• Consider enhanced traffic control at the crossing, such as an RRFB, PHB, or intersection signalization</li> <li>• Increase the size of the warning signs on the trail</li> <li>• Add lighting EB/WB ahead of the trail</li> </ul> |

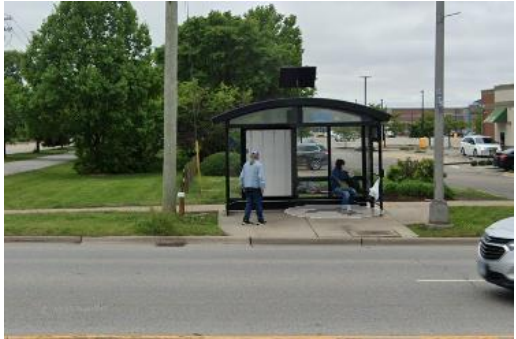
| Safety Measure | Image |
|---|---|
| <p><b>Bus Shelter/Transit Facility</b></p> | <p>A bus shelter is present on the west leg of the intersection, providing protection during inclement weather, and includes a concrete pad to facilitate an accessible path to the bus.</p> |

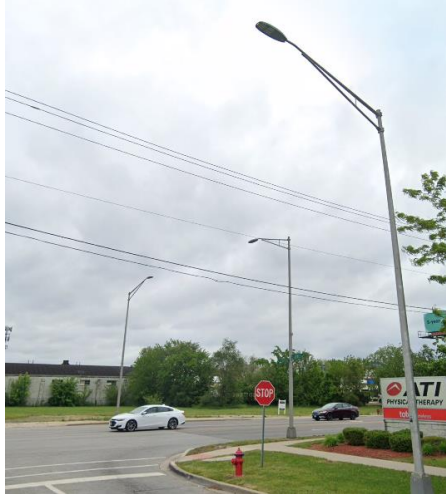
| Safety Measure | Image |
|---|---|
| <p><b>Lighting</b></p> | <p>Overhead lighting is provided at the intersection to provide sufficient nighttime visibility.</p> |
